**ENGINEERING SERVICES – RUNWAY REHABILITATION PROJECT**

**ADDENDUM #1, MONDAY, JANUARY 30, 2012**

**AIRFIELD PAVEMENT CONDITION SURVEY  
STRATFORD MUNICIPAL AIRPORT  
STRATFORD, ONTARIO**

PML Ref.: 06KF057  
Report: 1  
September 19, 2006

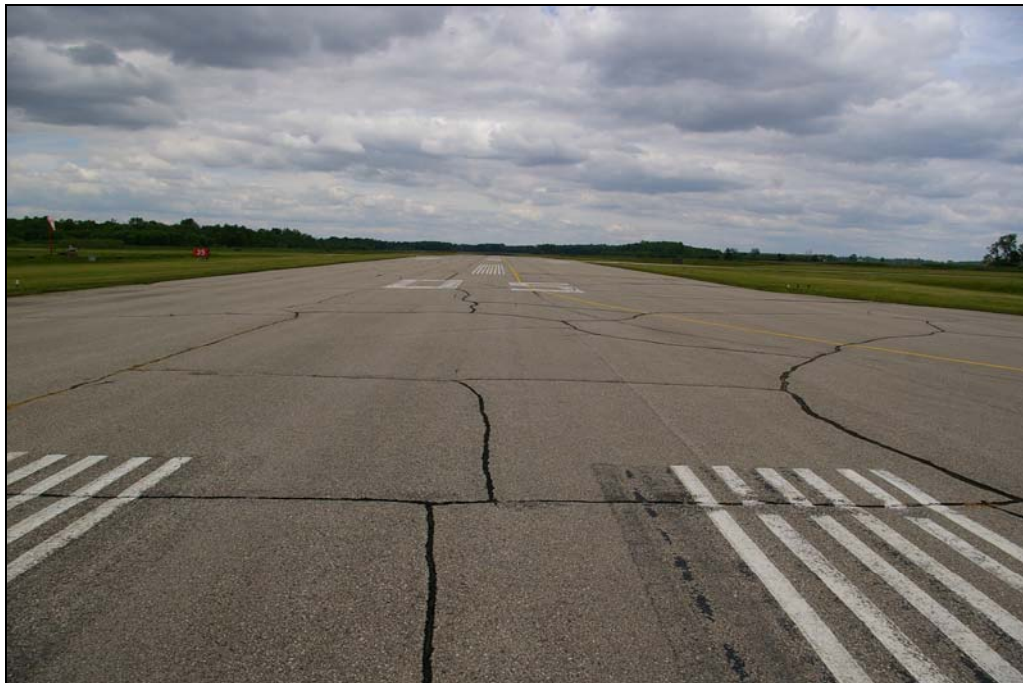
In general, the pavements constructed in 1988 all exhibit similar poor to fair pavement conditions. The 1988 pavements include the original length of Runway 05-23, 365 m of Runway 17-35 at the intersection with Runway 05-23, Taxiway A and the main Apron (which may have been constructed slightly later). In general, these pavements exhibit major transverse and longitudinal cracking. The longitudinal and transverse cracks are typically cupped and exhibit secondary cracking. Crack widths are up to 50 mm. Photo 1 through 8 show typical conditions of these pavements.

Photo 2: Typical condition of reconstructed portion of Runway 05-23 (1988 construction).

As an alternative, considering site conditions, we believe that the most suitable method of rehabilitation of the original portion of Runway 05-23, Runway 07-35 at the intersection, and Taxiway A would involve pulverizing the asphalt and mixing with the existing granular base. The exposed granular base could then be reggraded / reshaped to allow for grade adjustments, followed by placement of a minimum 50 mm of Granular A base and 80 mm of new HMAC placed in two lifts. This process would eliminate the potential for reflection cracking of the existing crack pattern through the new asphalt (compared to simply providing an overlay).

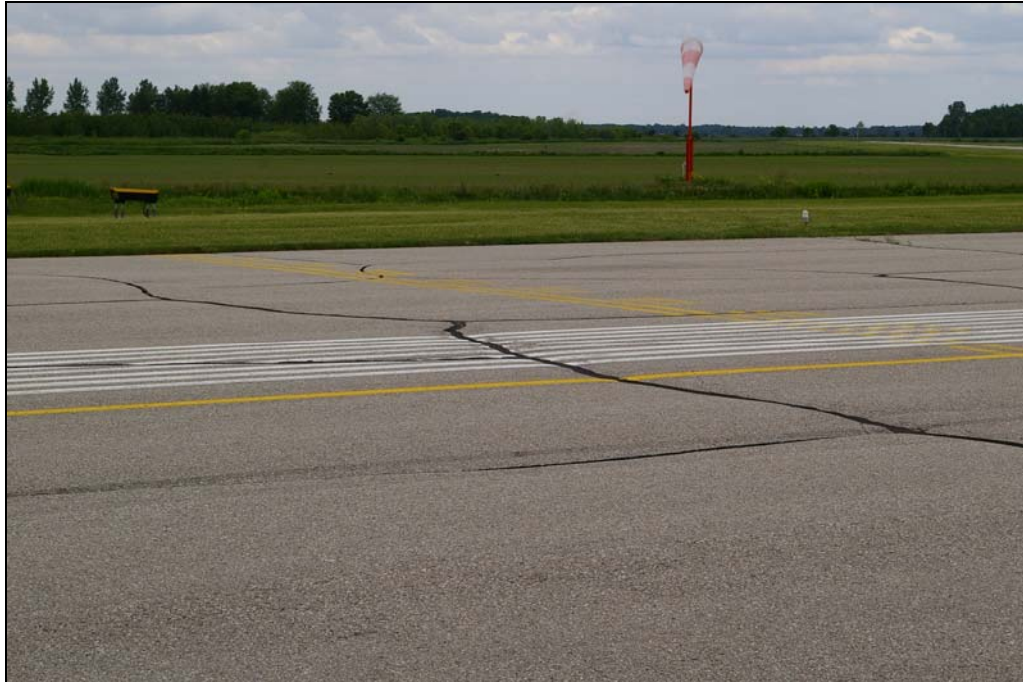
The documented distress on these airside pavement areas is generally associated with ageing and thermal effects. Consequently, future pavement rehabilitation is required to improve the surface/ride condition.

Photo 3: Typical transverse and longitudinal cracks on reconstructed portion of Runway 05-23. Note cupping at cracks.

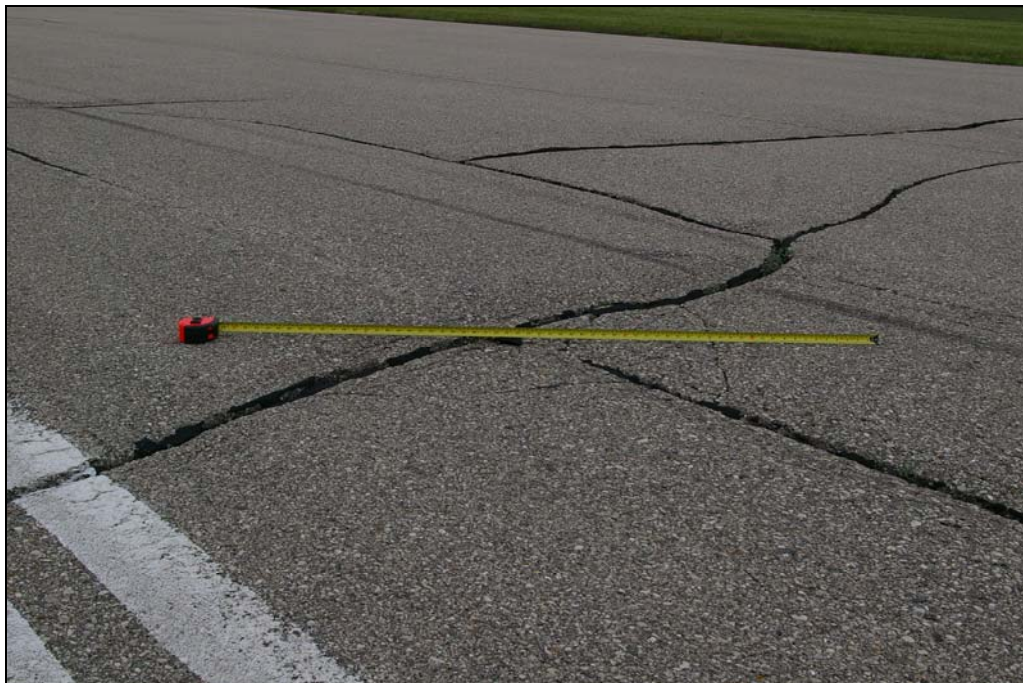
Photo 4: Typical transverse and longitudinal cracks on reconstructed portion of Runway 05-23. Note cupping at cracks.

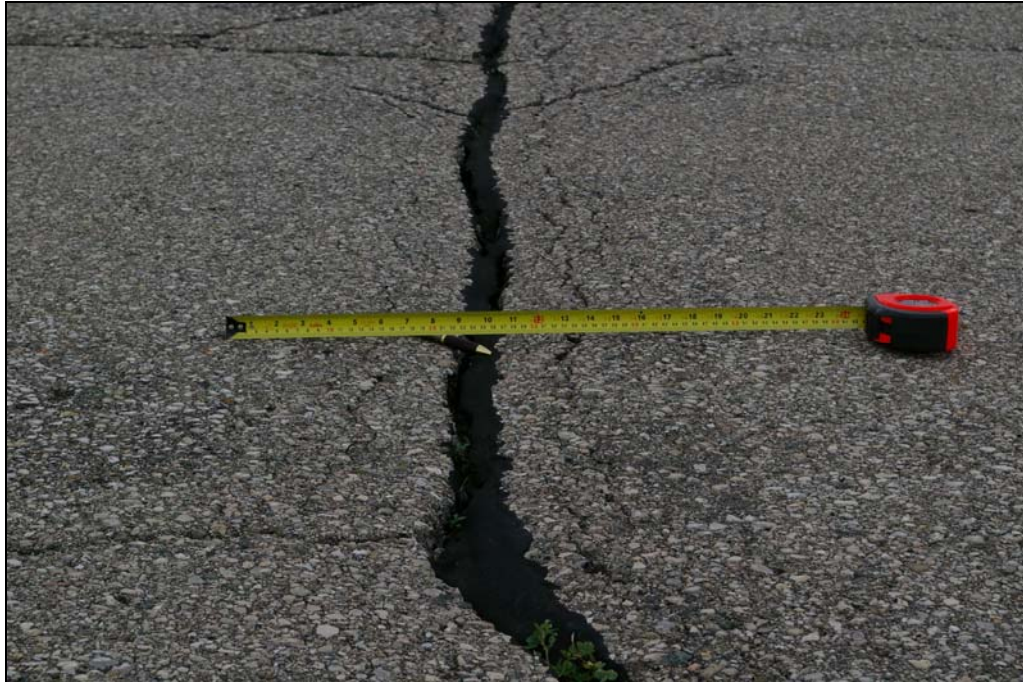
Photo 5: Typical transverse and longitudinal cracks on reconstructed portion of Runway 05-23. Note cupping and secondary cracking at cracks.

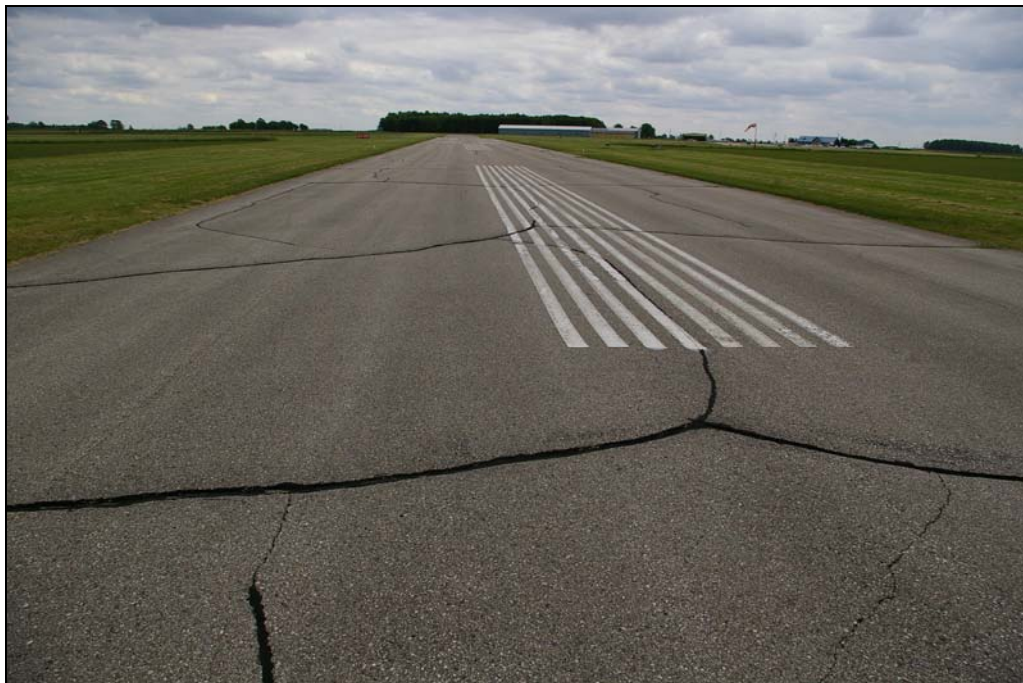
Photo 6: Typical condition of Runway 17-35 in the vicinity of intersection with Runway 05-23 (1988 construction).

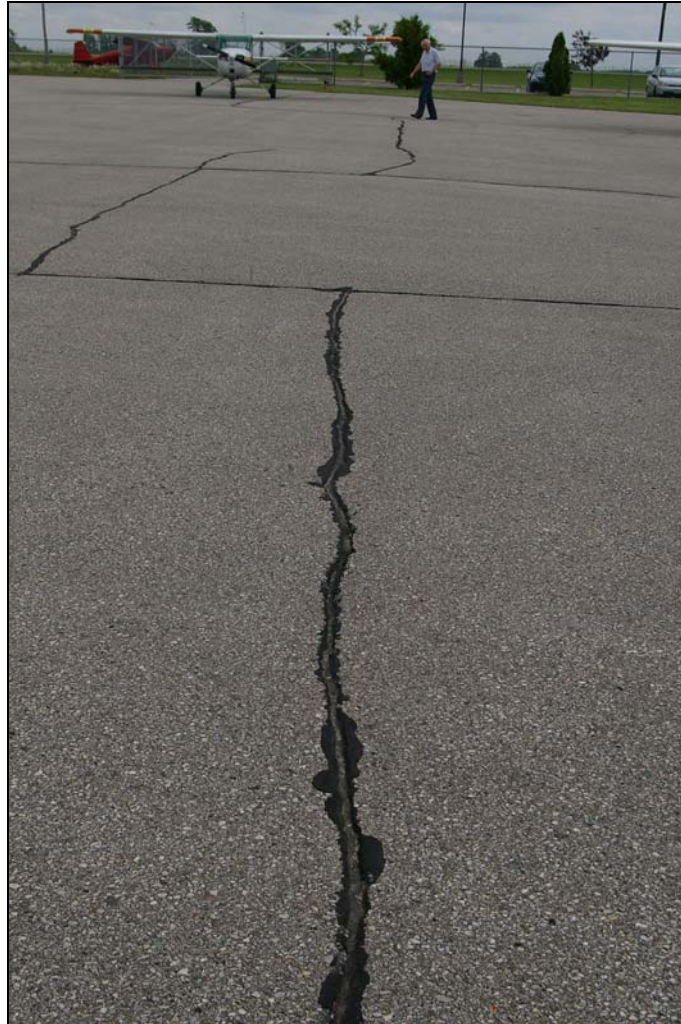
Photo 7: Typical condition of main Apron.

It is our opinion that the pavement on the original portion of Runway 05-23, Runway 07-35 at the intersection, Taxiway A and the Main Apron are experiencing significant distress and some form of rehabilitation is now required. One option would be to place an overlay on the existing asphalt, however, as noted previously the crack pattern in the existing asphalt is extensive and will reflect up through the new surface within a few years and then ongoing crack maintenance will be required. An overlay would be considered appropriate for the Main Apron, however, the cracks are too extensive on the remaining areas.

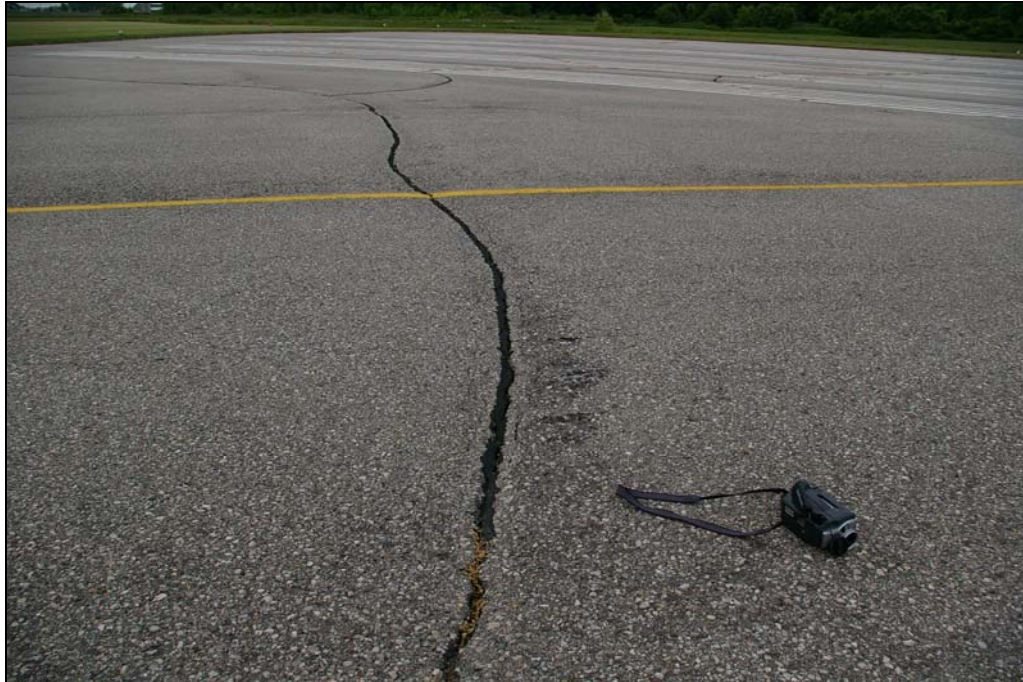
Photo 8: Typical condition of Taxiway A.

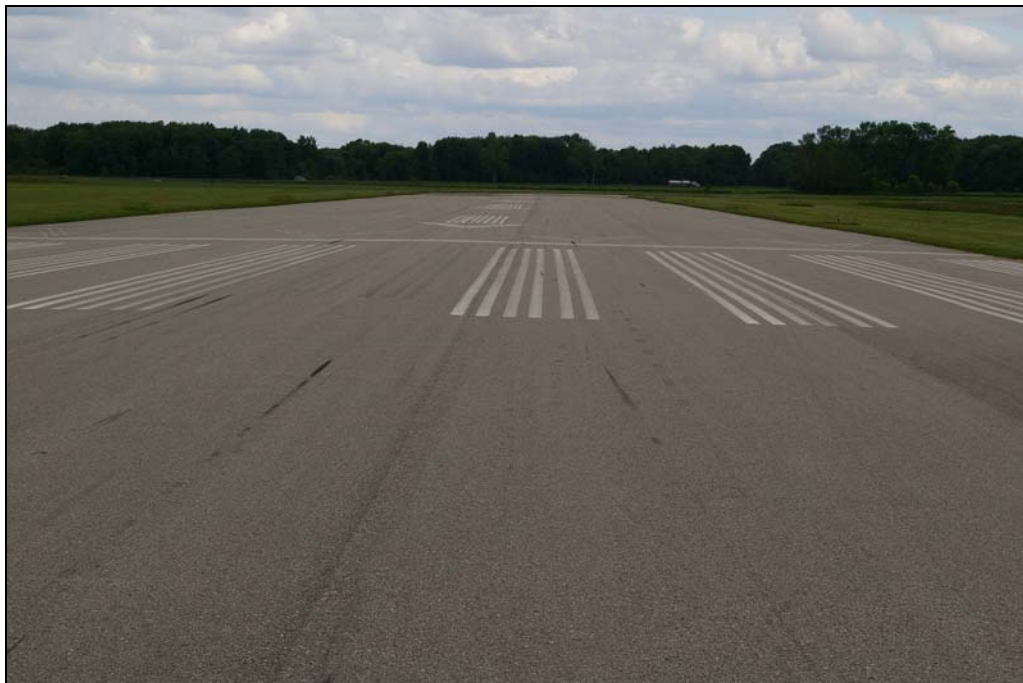
These pavements are exhibiting minimal transverse or longitudinal cracking. Typical photographs of these pavements are shown in Photos 9 through 14.

Photo 9: Typical condition of extension of Runway 05-23 (1993 construction).

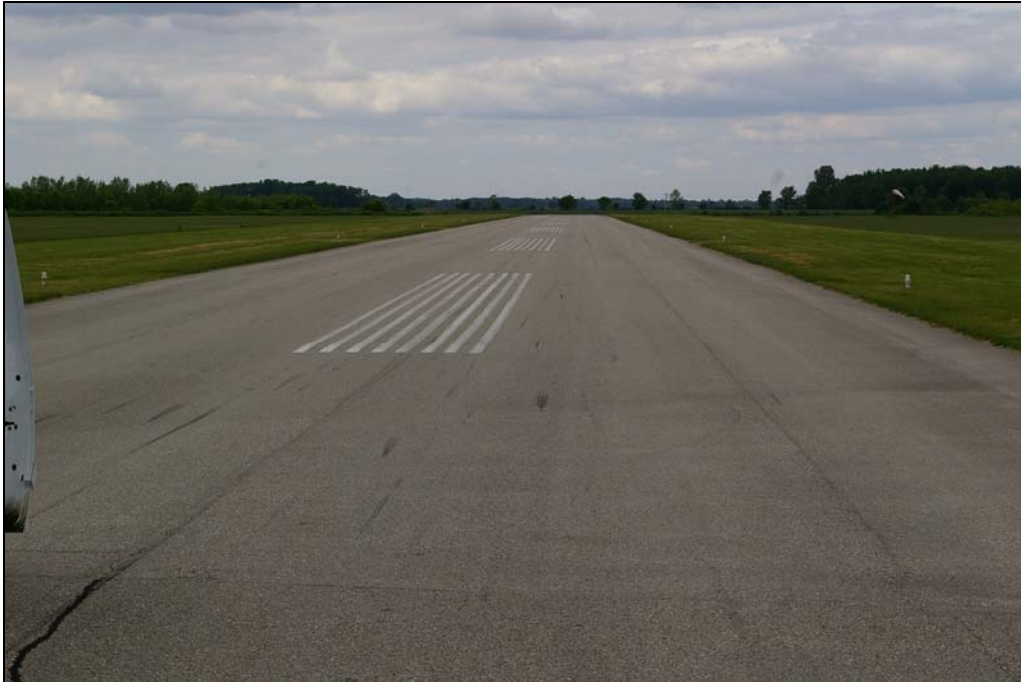
Photo 10: Typical condition of northern portion of Runway 17-35 (1995 construction).

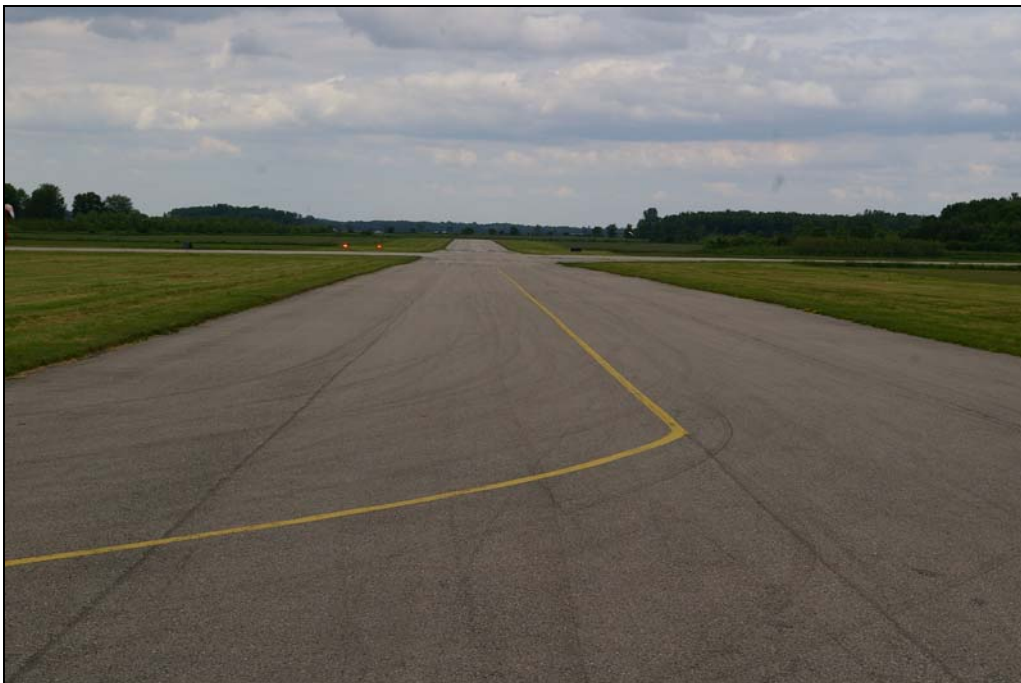
Photo 11: Typical condition of Taxiway B (abandoned Runway 17-35).

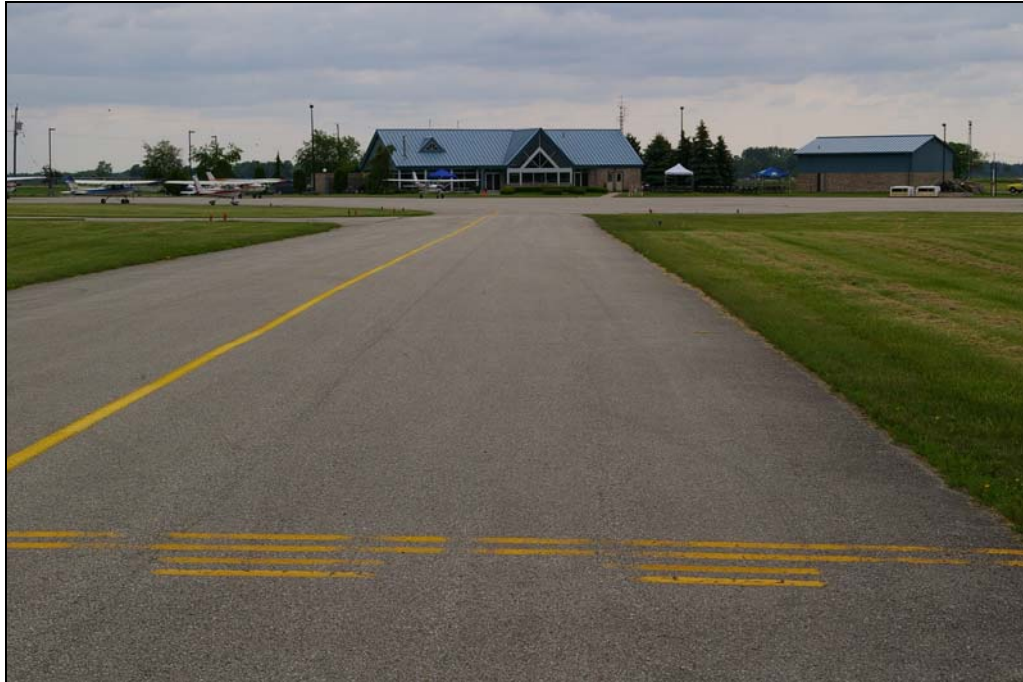
Photo 12: Typical condition of Taxiway B (E-W Portion).

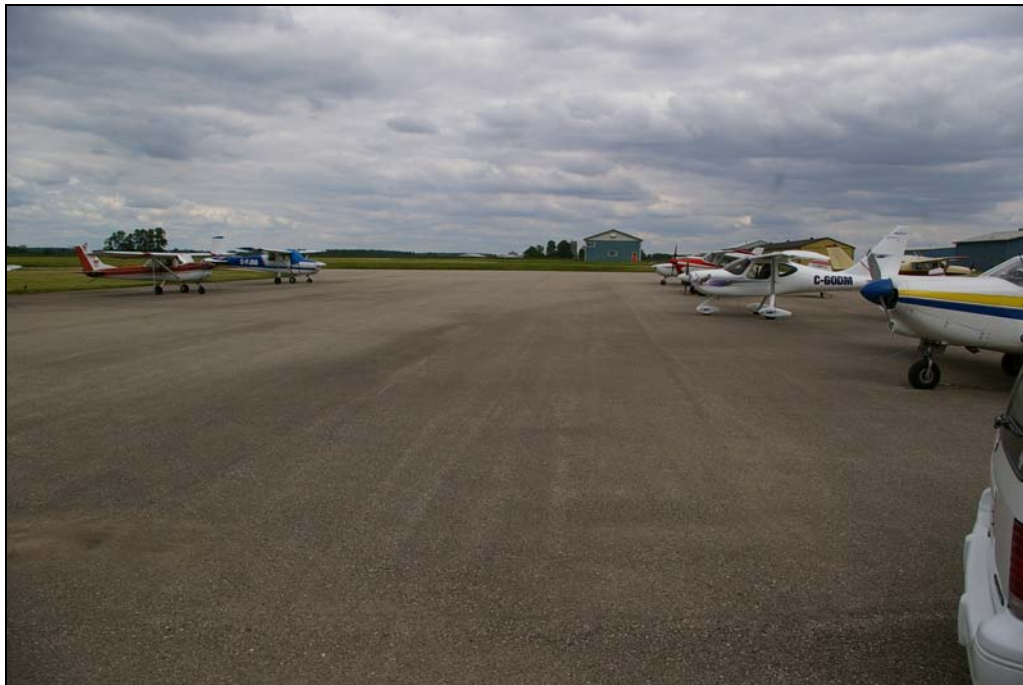
Photo 13: Typical condition of Apron Extension.

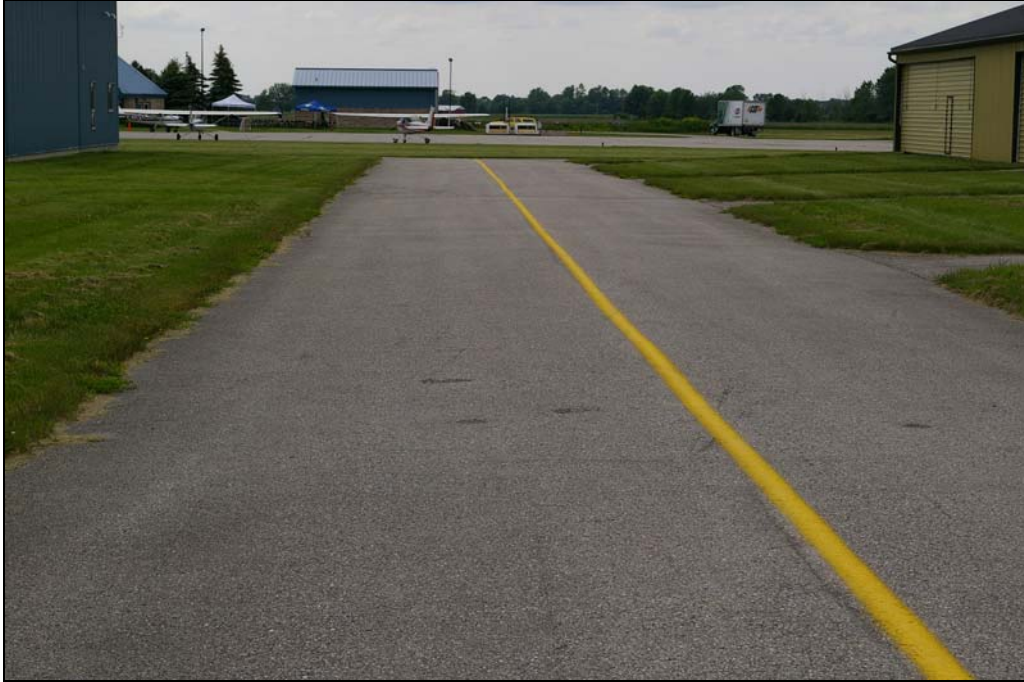
Photo 14: Typical condition of General Aviation Areas.
